(c) NATIONAL PHOTOGRAPHIC INTERPRETATION CENTER

REFERENCE TO: Mission 1101-1, MILITARY COMPLEX
TA-TUNG, CHINA

NATIONAL PHOTOGRAPHIC INTERPRETATION CENTER
MILITARY COMPLEX
TA-TUNG, CHINA
40-07N 113-16E

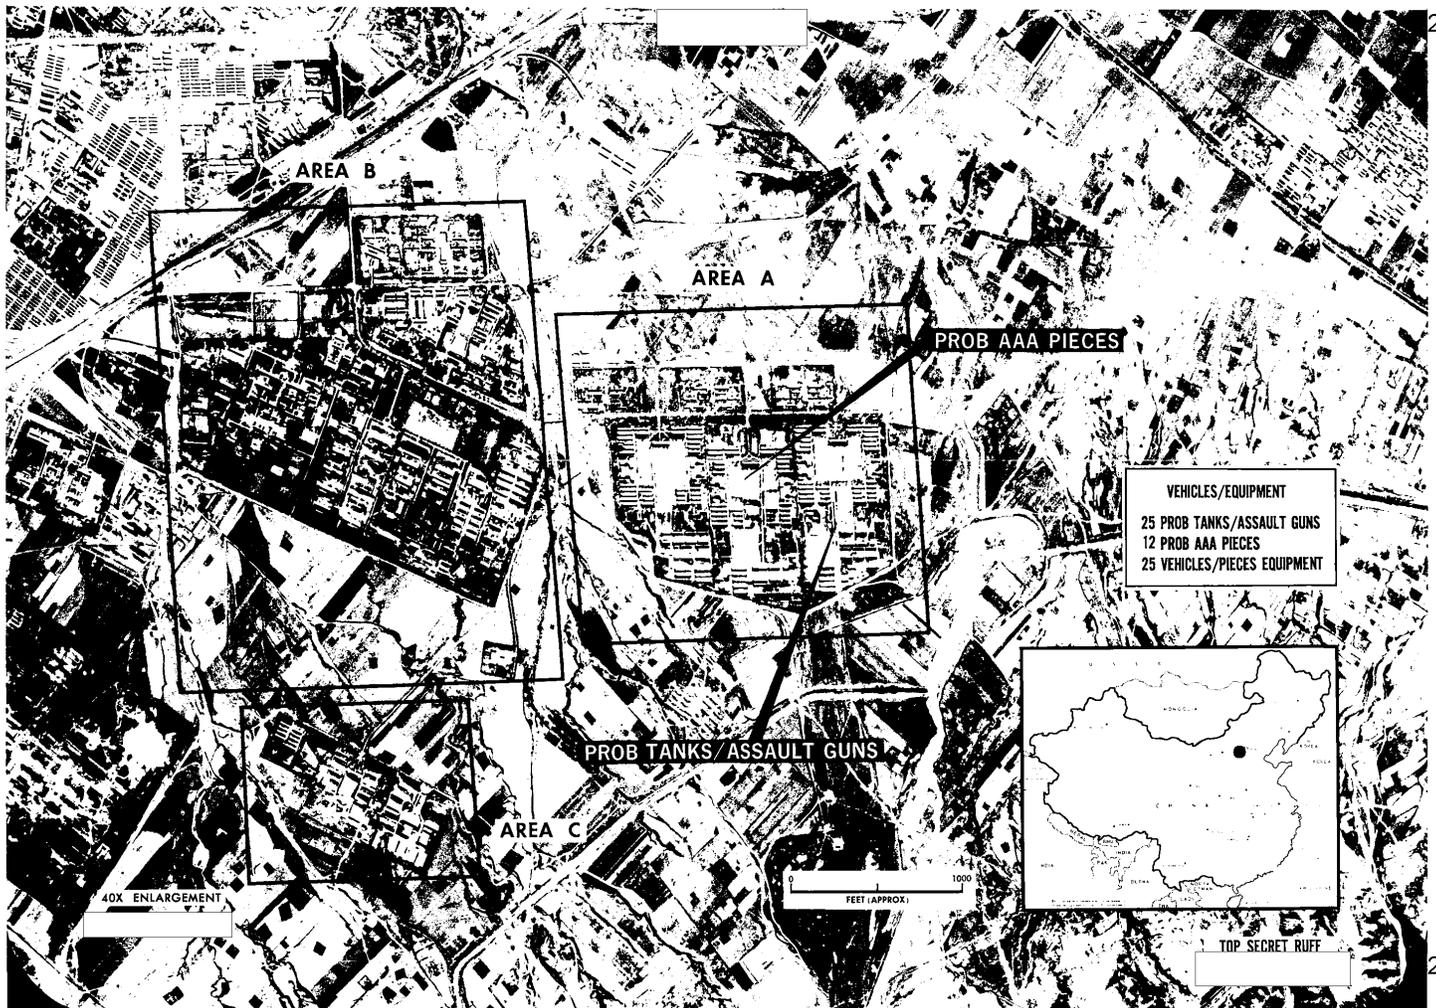
1. SIGNIFICANCE: TWENTY-FIVE PROBABLE TANKS/ASSAULT GUNS, 12
PROBABLE AAA PIECES, AND 25 VEHICLES/PIECES
OF EQUIPMENT ARE OBSERVED ON KH-4B PHOTOGRAPHY
AT TA-TUNG MILITARY COMPLEX.

3. REMARKS: LARGE, PROBABLE DIVISION SIZE MILITARY COMPLEX
CONSISTS OF 3 SECURED OR PARTIALLY SECURED AREAS.
AREA A (TA-TUNG ARMY BKS NW AREA 2,

AT 40-06-30N 113-15-25E) CONTAINS 3 NEARLY IDENTICAL
INFANTRY UNIT, REGIMENTAL-SIZE AREAS. EACH OF THE
AREAS CONTAIN 28 BARRACKS, 4 POSSIBLE BARRACKS, 2
BARRACKS/SUPPORT BUILDINGS, 17 TO 19 STORAGE BUILD-
INGS, 1 ADMINISTRATION BUILDING, 4 ADMINISTRATION/
SUPPORT BUILDINGS, AND APPROXIMATELY 5 MISCELLANEOUS
SUPPORT BUILDINGS. ALSO, EACH AREA HAS A SEPARATE
SMALL SUPPORT AREA.

AT 40-06-50N 113-16-10E) IS A PROBABLE ARTILLERY UNIT SIZE INSTALLATION CONTAINING 29 BARRACKS, 2 MULTISTORY BARRACKS/ADMINISTRATION BUILDINGS, 4 POSSIBLE BARRACKS, 3 MULTISTORY ADMINISTRATION BUILDINGS, A MULTISTORY PROBABLE ADMINISTRATION BUILDING, A LARGE MULTISECTIONAL BUILDING POSSIBLY USED AS A HOSPITAL, 20 TO 25 STORAGE BUILDINGS, AND 15 TO 20 MISCELLANEOUS SUPPORT SHEDS.

AT 40-07-20N 113-15-50E) IS A TANK/ASSAULT-GUN FACILITY CONTAINING 7 PROBABLE BARRACKS, 9 POSSIBLE BARRACKS, A MULTISTORY ADMINISTRATION BUILDING, 11 STORAGE BUILDINGS, AN ADMINISTRATION/SUPPORT BUILDING, 1 MESSHALL, 1 MAJOR MAINTENANCE BUILDING, AND 7 VEHICLE STORAGE BUILDINGS.
